SWA1801z REPAIR MANUAL

These instructions are intended to help restore any ailing SWA1801z Active Subwoofer back to factory working conditions. They show how to remove and replace the woofer and amplifier assembly.

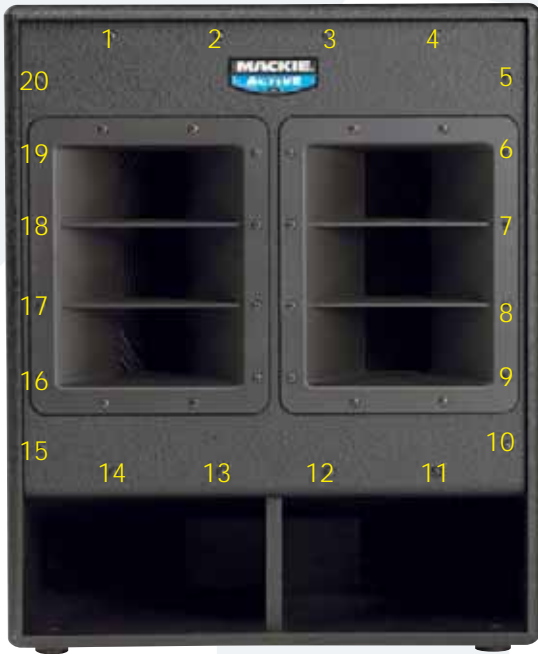
1 Twenty screws need to be removed from the front panel using the phillips head screwdriver.

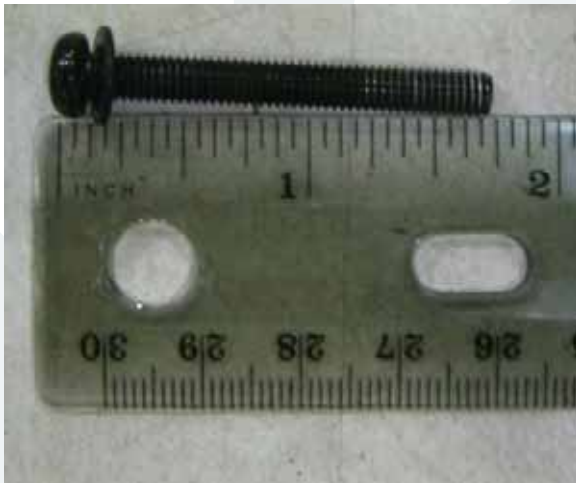
2 Keep the 20 screws and washers in a safe place.

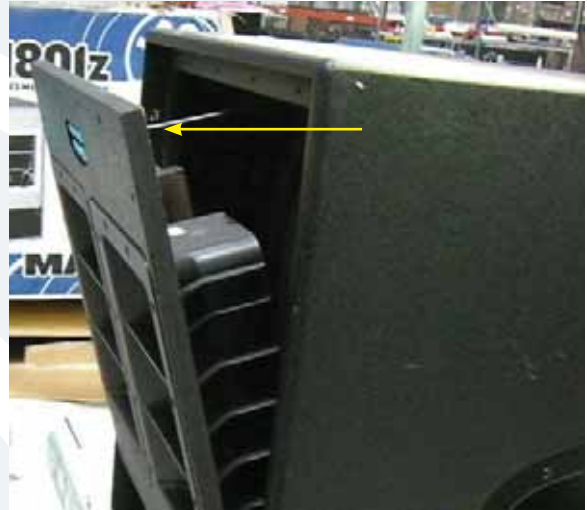
3 Carefully begin to remove the front panel. The wave guides are a great place to grip for stability and support. Do not fully remove the front panel as the cable is still attached to the led PCB assembly.

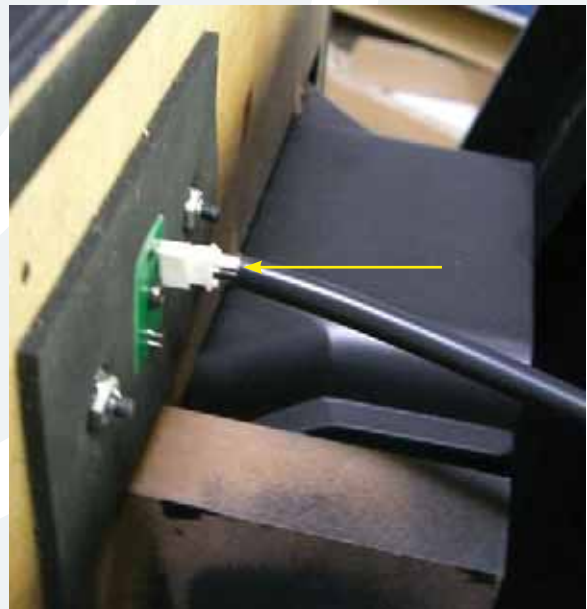
4 Carefully remove the cable attached to the led PCB assembly.

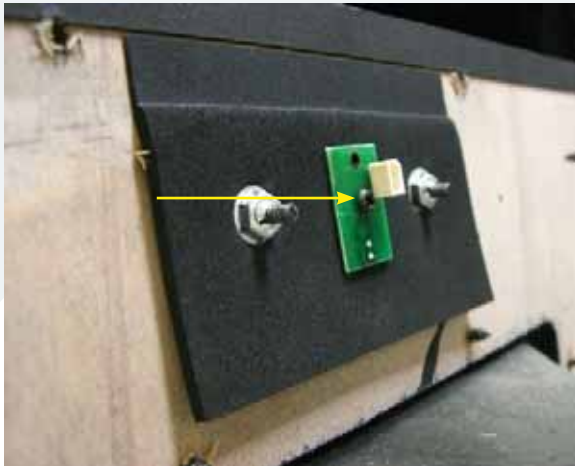
- 5** Use the phillips head screwdriver to remove one screw from the center of the led PCB assembly.

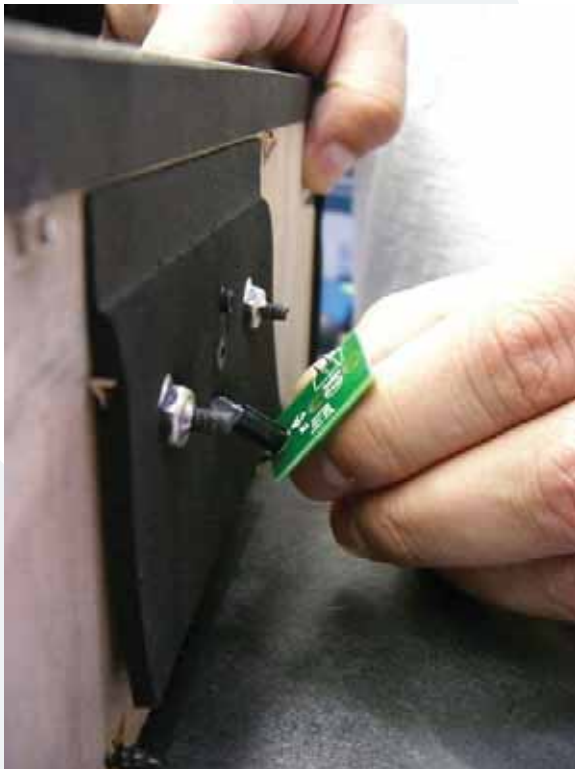
- 6** Carefully remove the led PCB assembly from the back side of the front panel. A flathead screwdriver may aid in removal of the led PCB assembly if it is sticking.

- 7** The hard part is done, the rest is easy! Place new led PCB assembly (part #0007334) where the old one was. Follow the same steps as above, but backwards 6 to 1. Power up the SWA1801z and led should light up. Congratulations, you just replaced an led PCB assembly...now go play some shows!

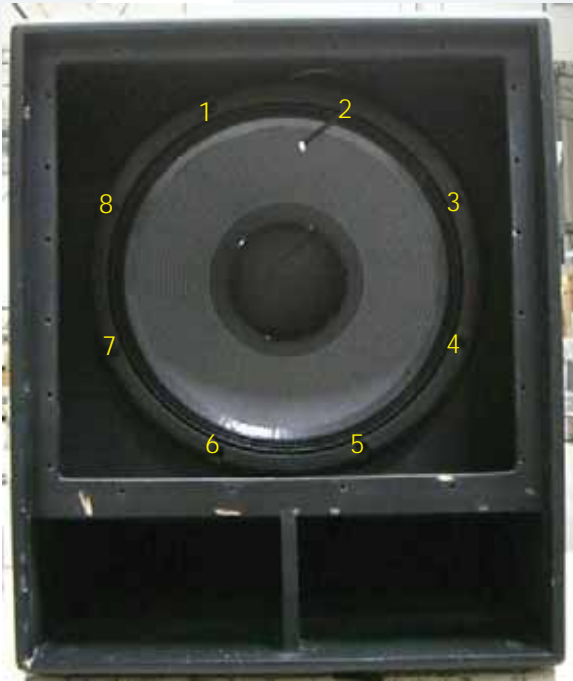
2 Eight screws need to be removed from the woofer using the 5mm allen wrench.

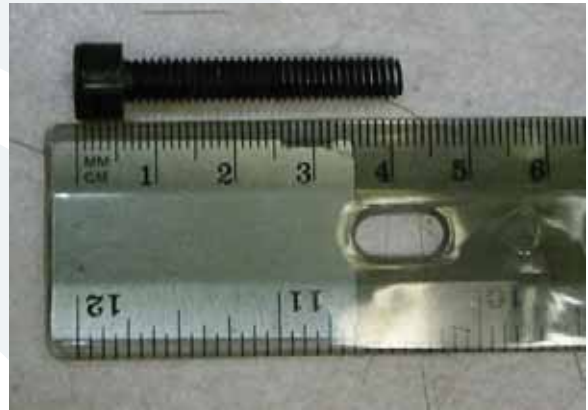
3 Keep the eight screws in a safe place.

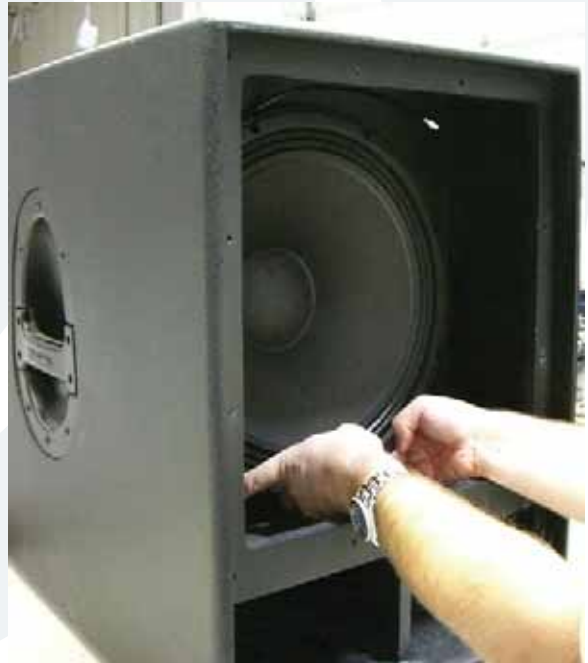
*** 4** Carefully begin to remove the woofer. A flathead screwdriver may aid in removal of woofer if it is sticking.

Caution: The woofer is approximately 27 pounds with weight unevenly distributed.

*This picture was taken during an SWA1501 woofer repair. The same principle applies to the SWA1801z.

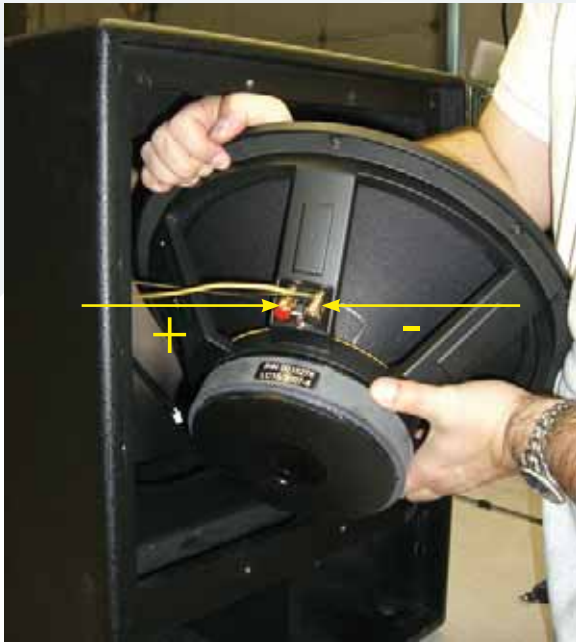
*** 5** Positive (solid yellow) and negative (yellow and black) cables are still attached to woofer terminals.

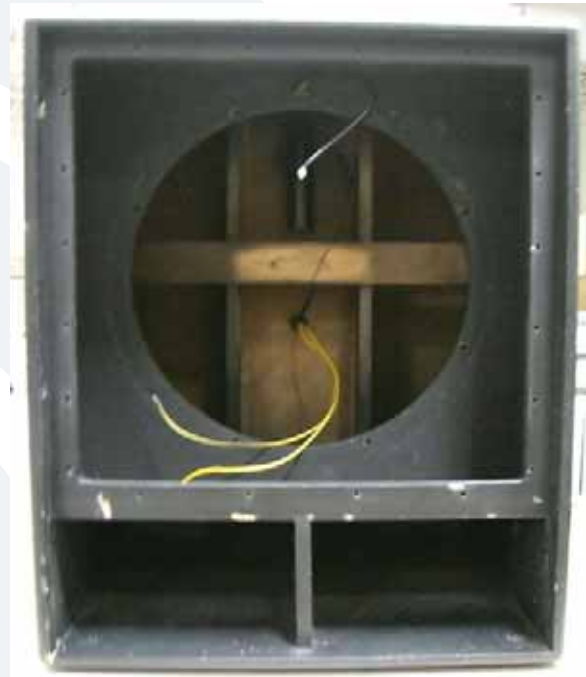
7 This is what it looks like with the front panel and woofer both removed. Place the new woofer (part #0012184) where the old one was. Follow the same steps as above, but backwards 6 to 1, making sure to keep the led PCB assembly cable in front of the woofer. Power up the SWA1801z and the new woofer should now be pumping out glorious lows. Awesome, you just replaced an 18" woofer!

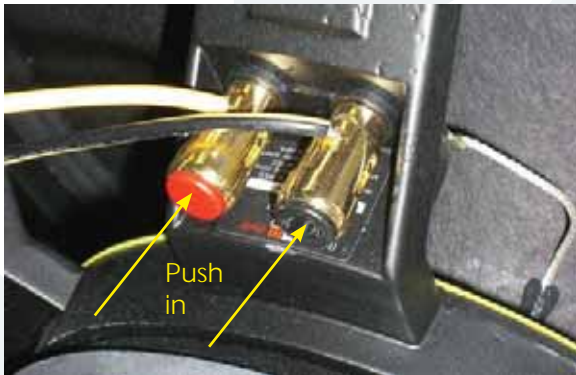
6 Remove cables from terminals simply by pushing down on terminal and pulling out cable.

*This picture was taken during an SWA1501 woofer repair. The same principle applies to the SWA1801z.

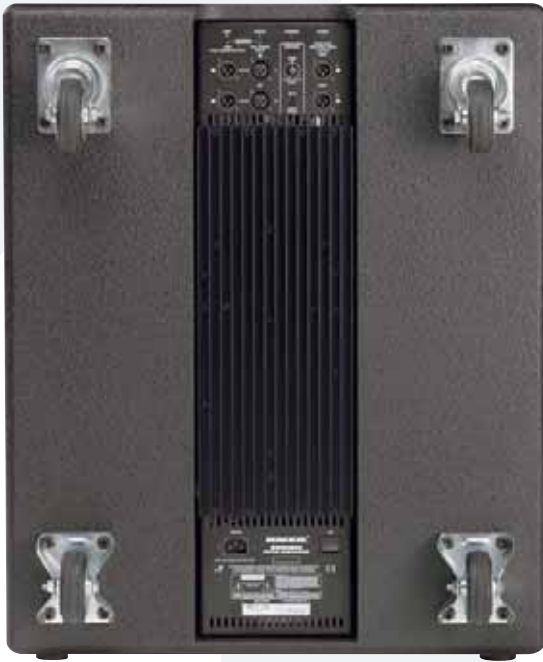
1 Four screws need to be removed from the amplifier assembly using a 5mm allen wrench. The screws are located at the top and bottom of the SWA1801z (see following pictures and further instructions).

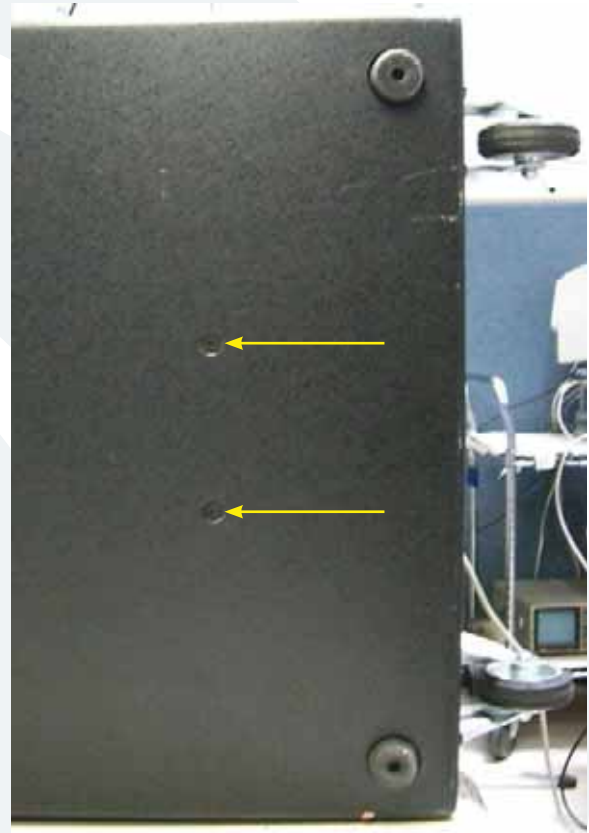
3 Last remaining two screws located on the bottom of the SWA1801z.

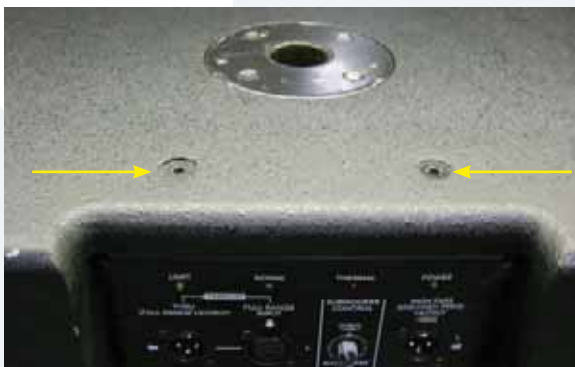
2 Two screws located on the top of the SWA1801z patiently awaiting removal.

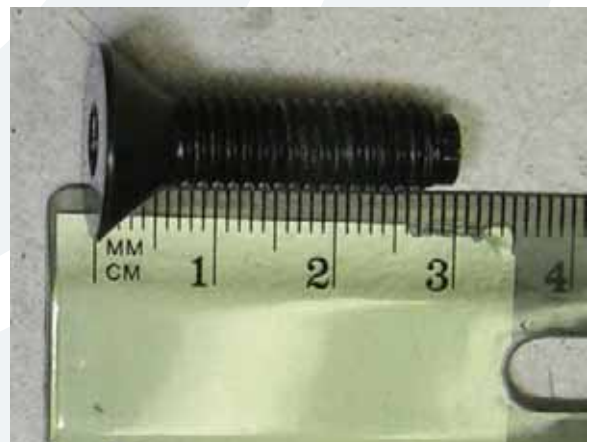
4 Keep the four screws in a safe place.

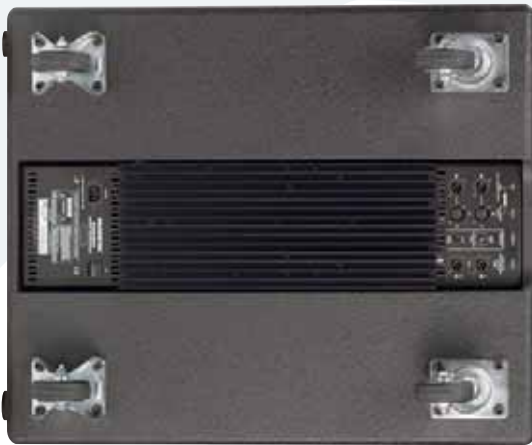
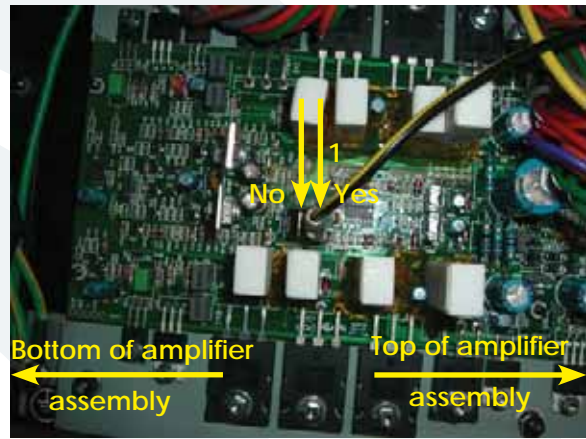
5 It may be easier to remove the amplifier assembly if the cabinet is on its side. Do not completely remove the amplifier assembly yet, as the cables need to be removed first.

Caution: The amplifier assembly is approximately 23 pounds, so please make sure to grasp it firmly.

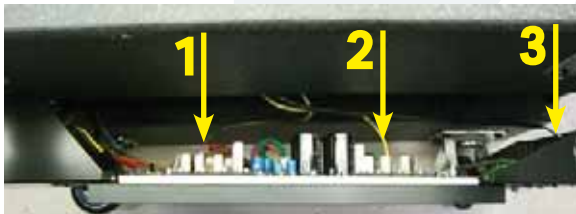
Side view

6a The terminal for the negative (yellow and black) woofer cable is located towards the bottom of the amplifier assembly, close to the transformer. The cable must be attached to the same terminal it was removed from. Failure to do so will result in greatly reduced power.

6 Three cables need to be removed from the amplifier assembly: (1) negative (yellow and black) cable, (2) positive (solid yellow) cable, and (3) led PCB cable. Do not force cable removal or connection, although needle-nose pliers may aid in gently removing the woofer cables. Notice their placement, as well (see following 3 pictures).

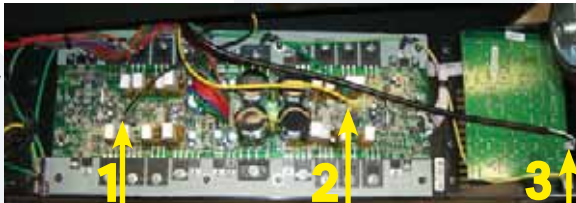
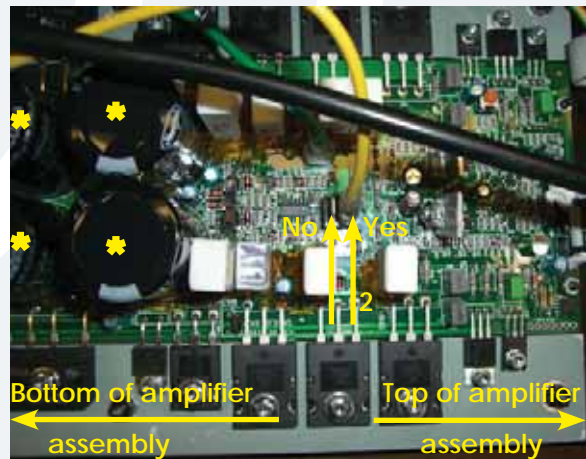
Bottom view

6b The terminal for the positive (solid yellow) woofer cable is located near the center of the amplifier assembly, just above the four capacitors (dotted above). The cable must be attached to the same terminal it was removed from. Failure to do so will result in greatly reduced power.

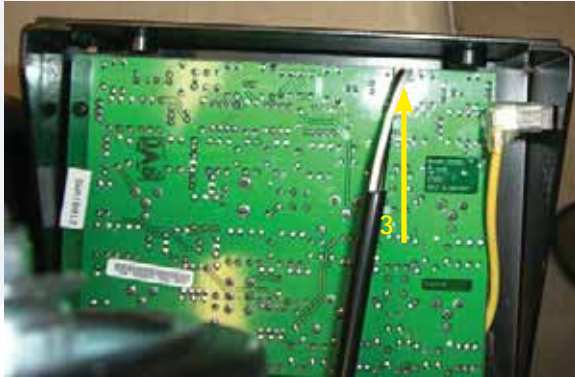
6c The led pcb cable attaches to the connector (as shown in picture above) with the white cable closest to the edge of the amplifier assembly.

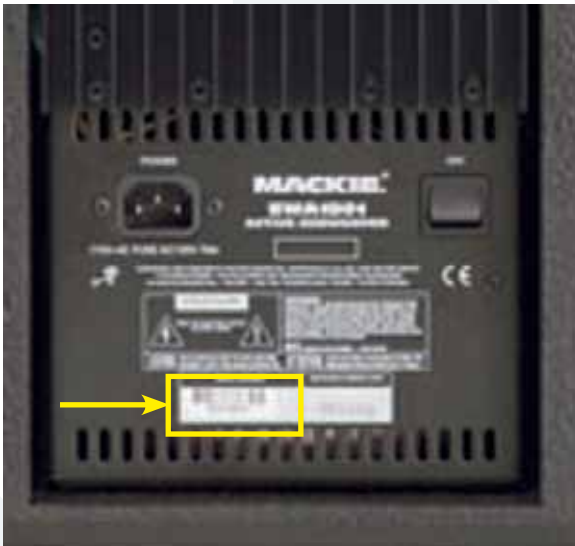
7 Place the new amplifier assembly (part #0016875) where the old one was. Follow the same steps as above, but backwards 6 to 1. Remove the serial number from the faulty amplifier assembly (as shown in picture above) and place on the new amplifier assembly. Power up the SWA1801z and relish in the fact that you just replaced an amplifier assembly. Hats off to you for a job well done!
